California Division of Mines and Geology

Fault Evaluation Report FER-86

March 21, 1979

Branches of the San Andreas fault system, including the Mission Creek fault, the Banning fault, the Garnet Hill fault, and other local fault segments.

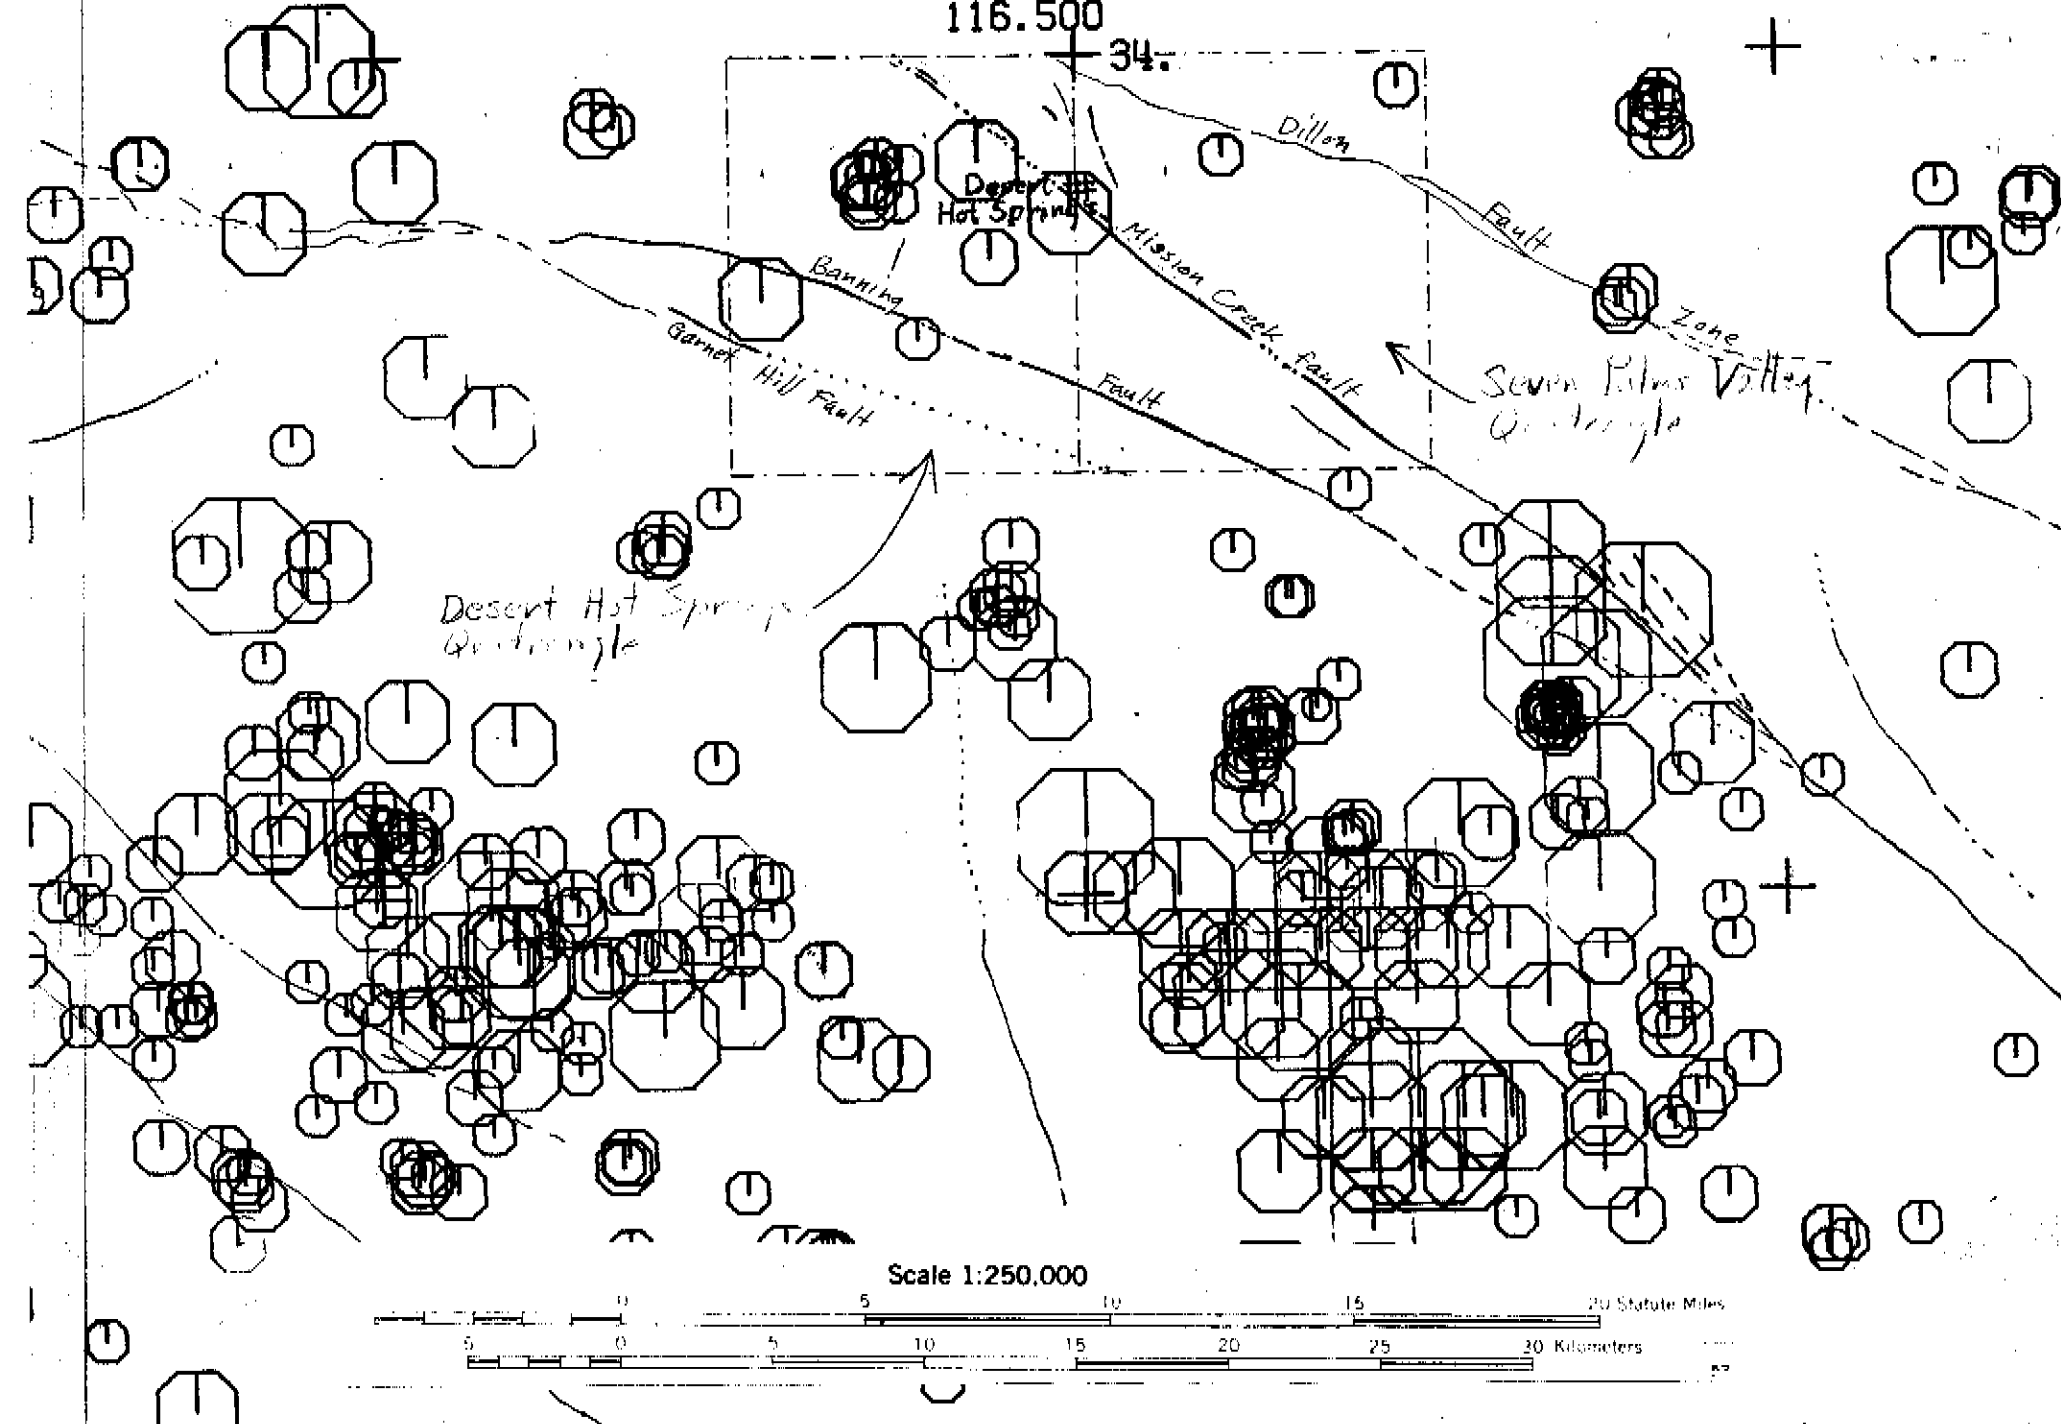
Figure 2. Seismicity in the region of Desert Hot Springs.

The "A" quality epicenter map (Figure 2) shows this area to have somewhat less seismicity than surrounding areas, especially to the south. Two epicenters appear to lie on the Mission Creek fault, and two on the Banning fault. This is fairly good correlation with those two faults. An unusually tight cluster of small magnitude events occurred just north of the DHS-B fault.

There are no events along the Garnet Hill fault, and only minor activity along the Dillon fault zone.

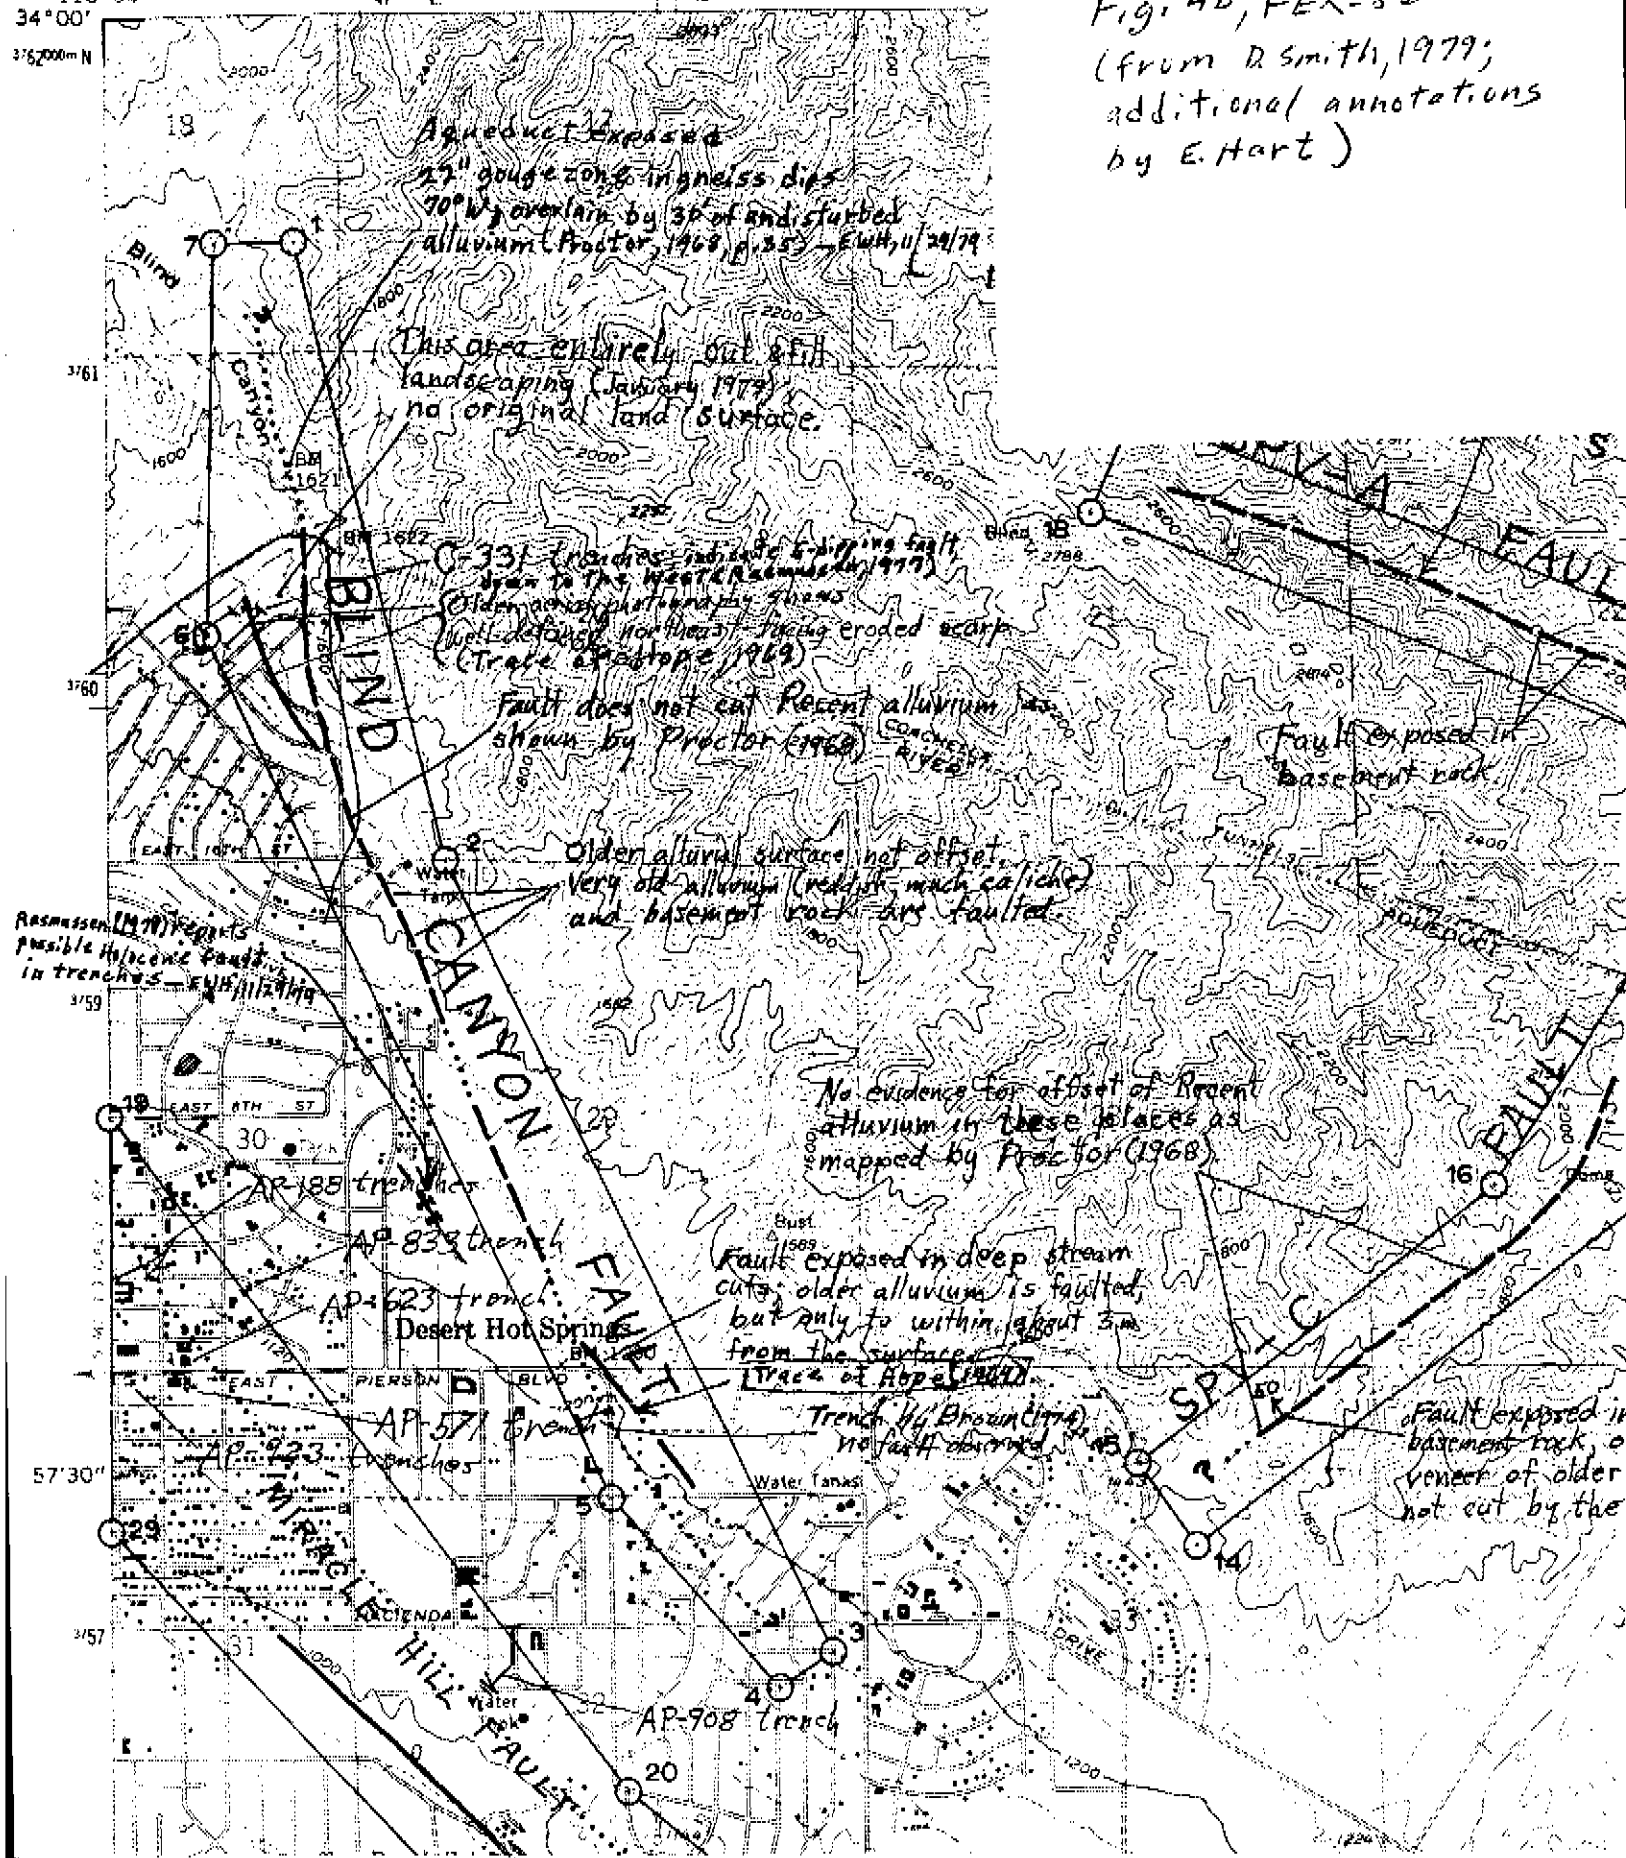
Fig. 4b, FER-86
(from R Smith, 1979;
additional annotations
by E. Hart)

The generalizations made about my remapping of the Banning fault apply as well to the Mission Creek fault. The specifics, of course, are different. There is a major error in the location of the fault trace in the central part of the Seven Palms Valley quadrangle SSZ map (Figure 4b). That depiction of the fault trace is taken from Proctor (1968). The fault-generated surface features actually lie about 200 m to the southwest, as shown on Figure 3b.

This fault occurs near the northwestern corner of the Seven Palms Valley quadrangle. As it is shown on the SSZ map (Figure 4b), it represents a compilation of the mapping of both Proctor (1968) and Hope (1969). Parts of this fault are clearly visible on older aerial photos, especially the northern part where an older alluvial surface and a bedrock pediment surface are clearly offset in a vertical sense. Those scarps no longer exist, as that area was recently modified by large-scale cut-and-fill landscaping. I examined the central and southern parts of this fault on the ground. I observed the fault to cut both the crystalline basement rock and a very old alluvial unit that overlies the basement rock in some places. Another older alluvial unit, and surface, which overlay the above two units, is not offset by the fault. I believe that the surface is older than Holocene age. I observed additional exposures of the fault near the southern end (see annotations on Figure 4b). There the fault is exposed in deep stream cuts. An older alluvial unit is faulted, but the faulting extends only to within about 3 m of the surface of that unit. I believe that the surface may be older than Holocene age. An exploratory trench by Brown (1974) located about 100 m west of the southern part of the fault (see Figure 4b for trench location) uncovered no evidence for faulting. Rasmussen (1977a) conducted trenching across the northern end of the fault (trench C-331 on Figure 4b), observed the fault in two of the trenches, and concluded (p. 8) that the Blind Canyon fault is "...possibly an active fault based on the definitions for active faulting provided by the State Mining and Geology Board." In other words, he is saying that the fault may have been active during Holocene time. I disagree. I examined the area of Rasmussen's trenching on older photography (Fairchild C-16107, 1951). At that time, this area had not been disturbed by the

This is steeply-dipping, west-northwest-trending fault that occurs in the north-central part of the Seven Palms Valley quadrangle (Figure 4b). It was mapped by Proctor (1968) as part of the Dillon fault zone. I examined the eastern half of this fault on the ground. The fault is characterized by a 15 cm to 20 cm wide gouge zone within a 15 m to 30 m wide mildly cataclastic zone. The fault generally lies beneath the modern alluvium of the canyon bottom, but locally is exposed in the granitic and metamorphic bedrock of the canyon walls at bends in the canyon. There is no direct evidence for or against Holocene offset. The modern alluvium is not faulted, and there are no older alluvial deposits along this canyon. Where the faulted bedrock is exposed, the geomorphic features do not suggest movement as recent as Holocene time.

This is a north-south-trending fault that lies in the north-central part of the Seven Palms Valley quadrangle (Figure 4b). Proctor (1968) mapped this fault and called it the Long Canyon fault. I examined parts of this fault on the ground. I saw no evidence for offset of Recent-Holocene alluvium at the northern and southern ends of the fault, as indicated by Proctor (1968, Plate 1) (see annotations on Figure 4b). I observed faulting in the crystalline basement rock at several localities. Along the southern third of the fault, the trace lies a short distance into the eastern wall of the canyon, instead of passing directly down the middle of the canyon as shown on Figure 4b. Remnants of an older alluvial surface on the eastern side of the canyon appear to have been faulted with the western side upthrown about one meter. The topographic expression of this offset is very indistinct, suggesting that the faulting there has not been recent. Farther to the north, in the central part of the fault, an older alluvial terrace surface overlying the fault has not been offset.

This is a northeast-trending fault that occurs to the west of Long Canyon (Figure 4b). The fault is exposed at several places in the crystalline basement rock, and shows a dip of 50° to the northwest accompanied by several inches of gouge. An overlying veneer of older alluvium is not cut by the fault. Proctor (1968, Plate 1) shows this fault cutting Recent alluvium at two places (see annotation, Figure 4b). I found no evidence for faulting of the Recent alluvium in those places.

These fault segments occur near the southeastern corner of the Seven Palms Valley quadrangle (Figure 4b). The SPV-D fault was mapped by Proctor (1968) and the SPV-E fault was mapped by Hope (1969). The faults occur mainly within older alluvial strata of Pleistocene age. The geomorphic features along these two fault segments have been extensively modified by erosion. There is no surface expression of the faults along most of their lengths. Locally, I observed Holocene or older alluvium, that overlies the faults, to not be cut.

This fault lies about one kilometer to the northeast of the Mission Creek fault, in the eastern side of the Seven Palms Valley quadrangle (Figures 3b and 4b). The fault, as shown on the SSZ map (Figure 4b), represents mapping by both Proctor (1968) and Hope (1969). I have remapped it as shown with annotations on Figure 3b. I perceive this fault to be composed of several overlapping arcuate traces. Locally the geomorphic expression is very youthful (see annotation on Figure 3b). Although I could find no actual exposure of the fault place, I suspect that this fault is composed of a series of small, overlapping thrust plates, with southwest dipping fault planes converging with the Mission Creek fault at depth.

I recommend the deletion of the Miracle Hill fault as presently shown on the official SSZ map (Figure 4), and then a new delineation of the fault as shown on Figure 3b, along with an appropriate change in the zone.

I recommend total deletion of the zones along the DHS-A feature, the Blind Canyon fault, and the SPV-A, SPV-B, SPV-C, SPV-D, and SPV-E faults.

I recommend re-delineation of the Fun Valley fault, accompanied by appropriate zone adjustment.

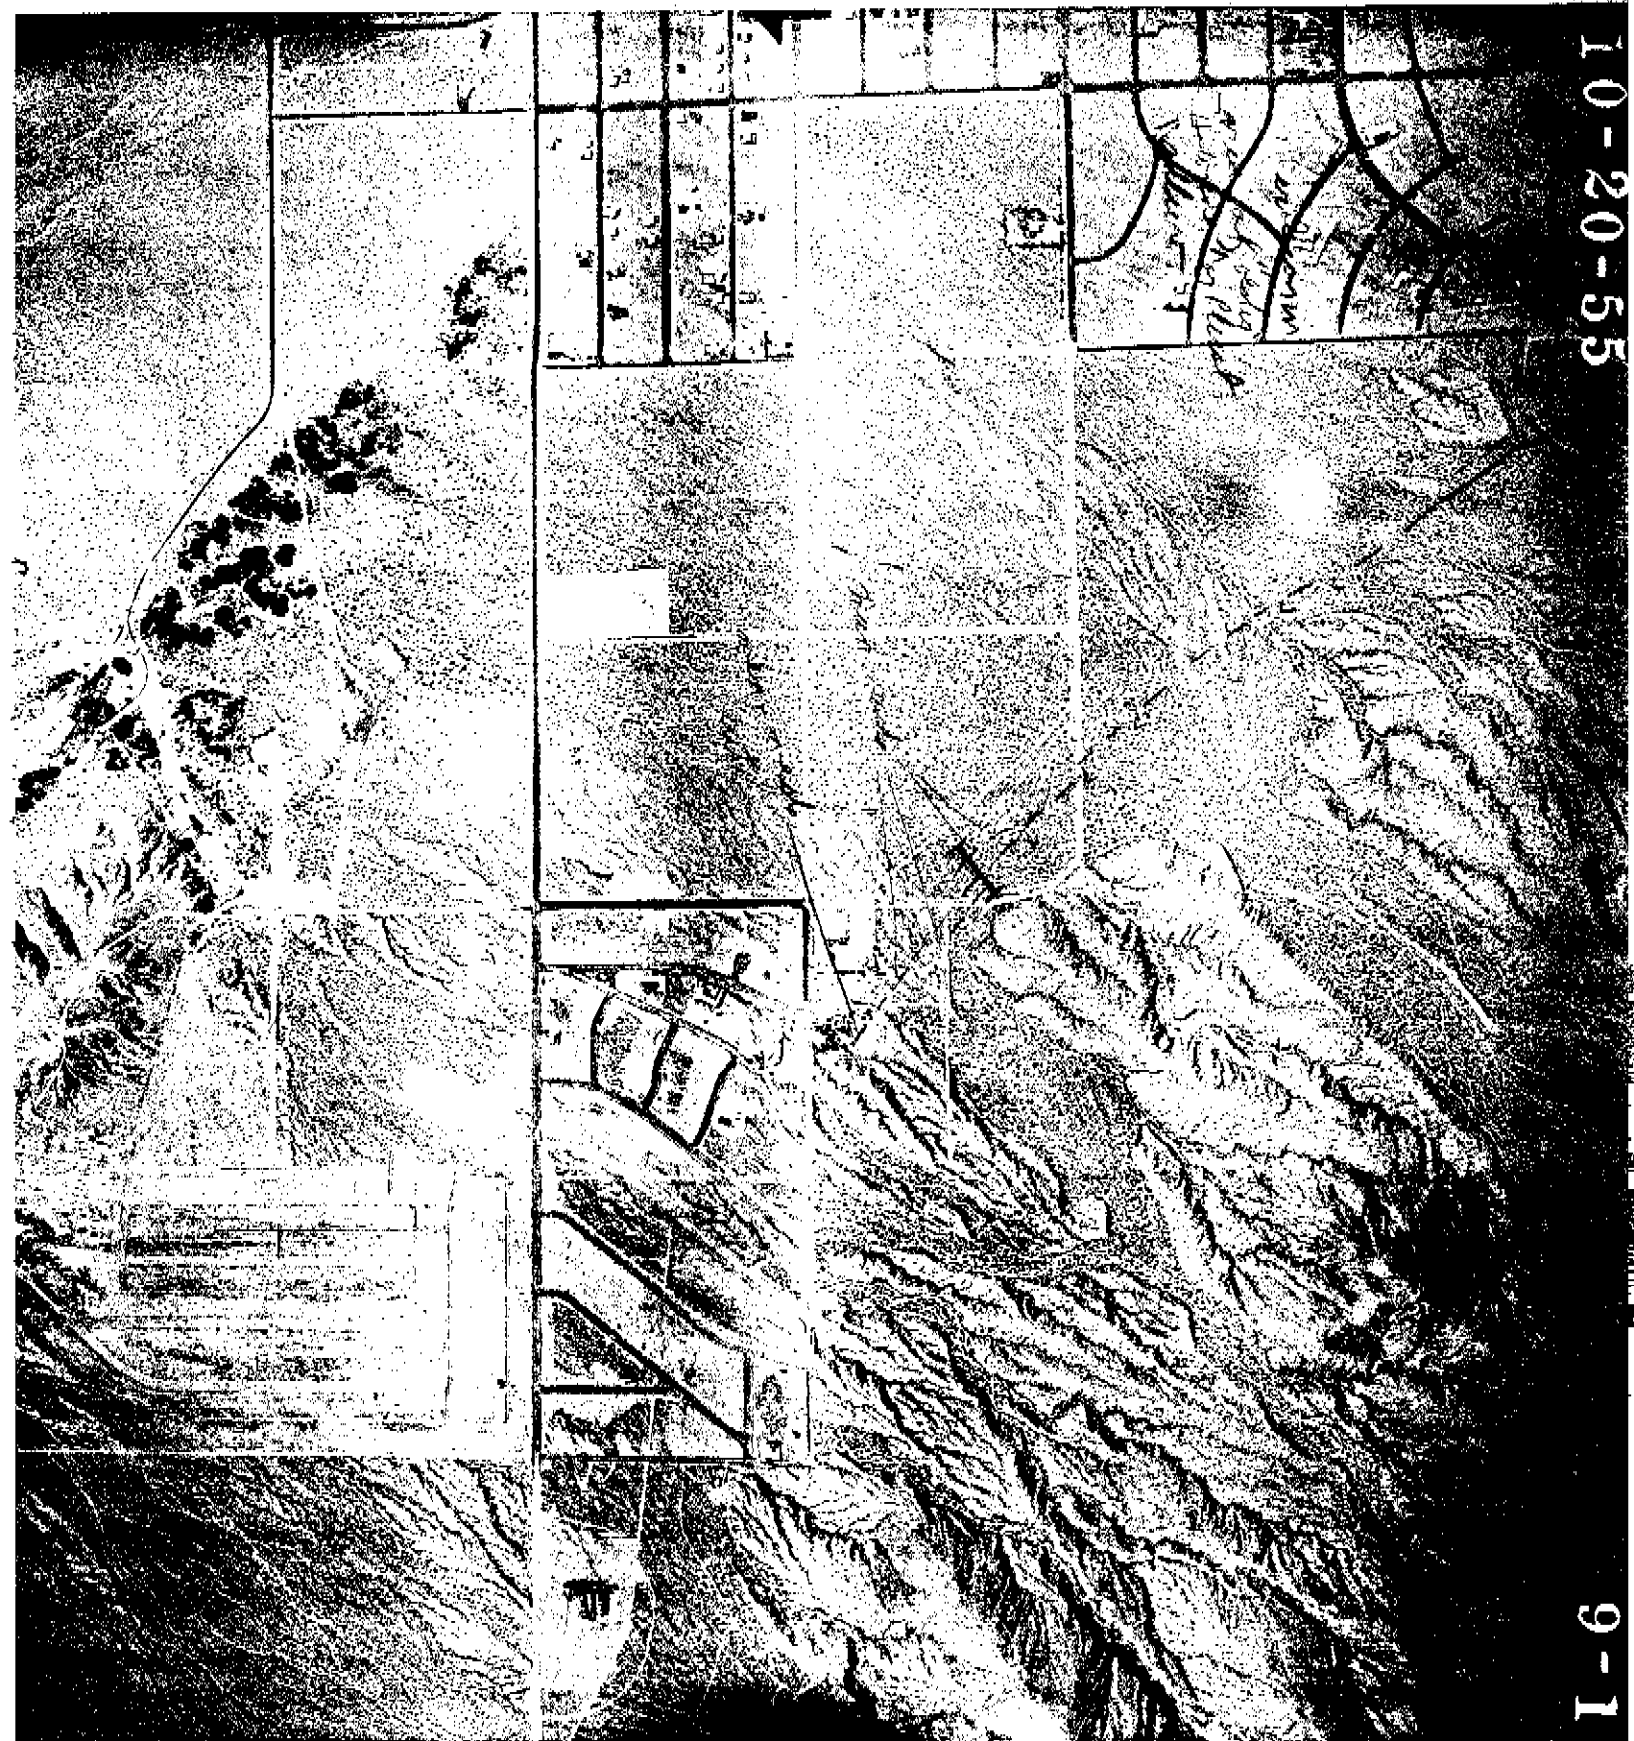
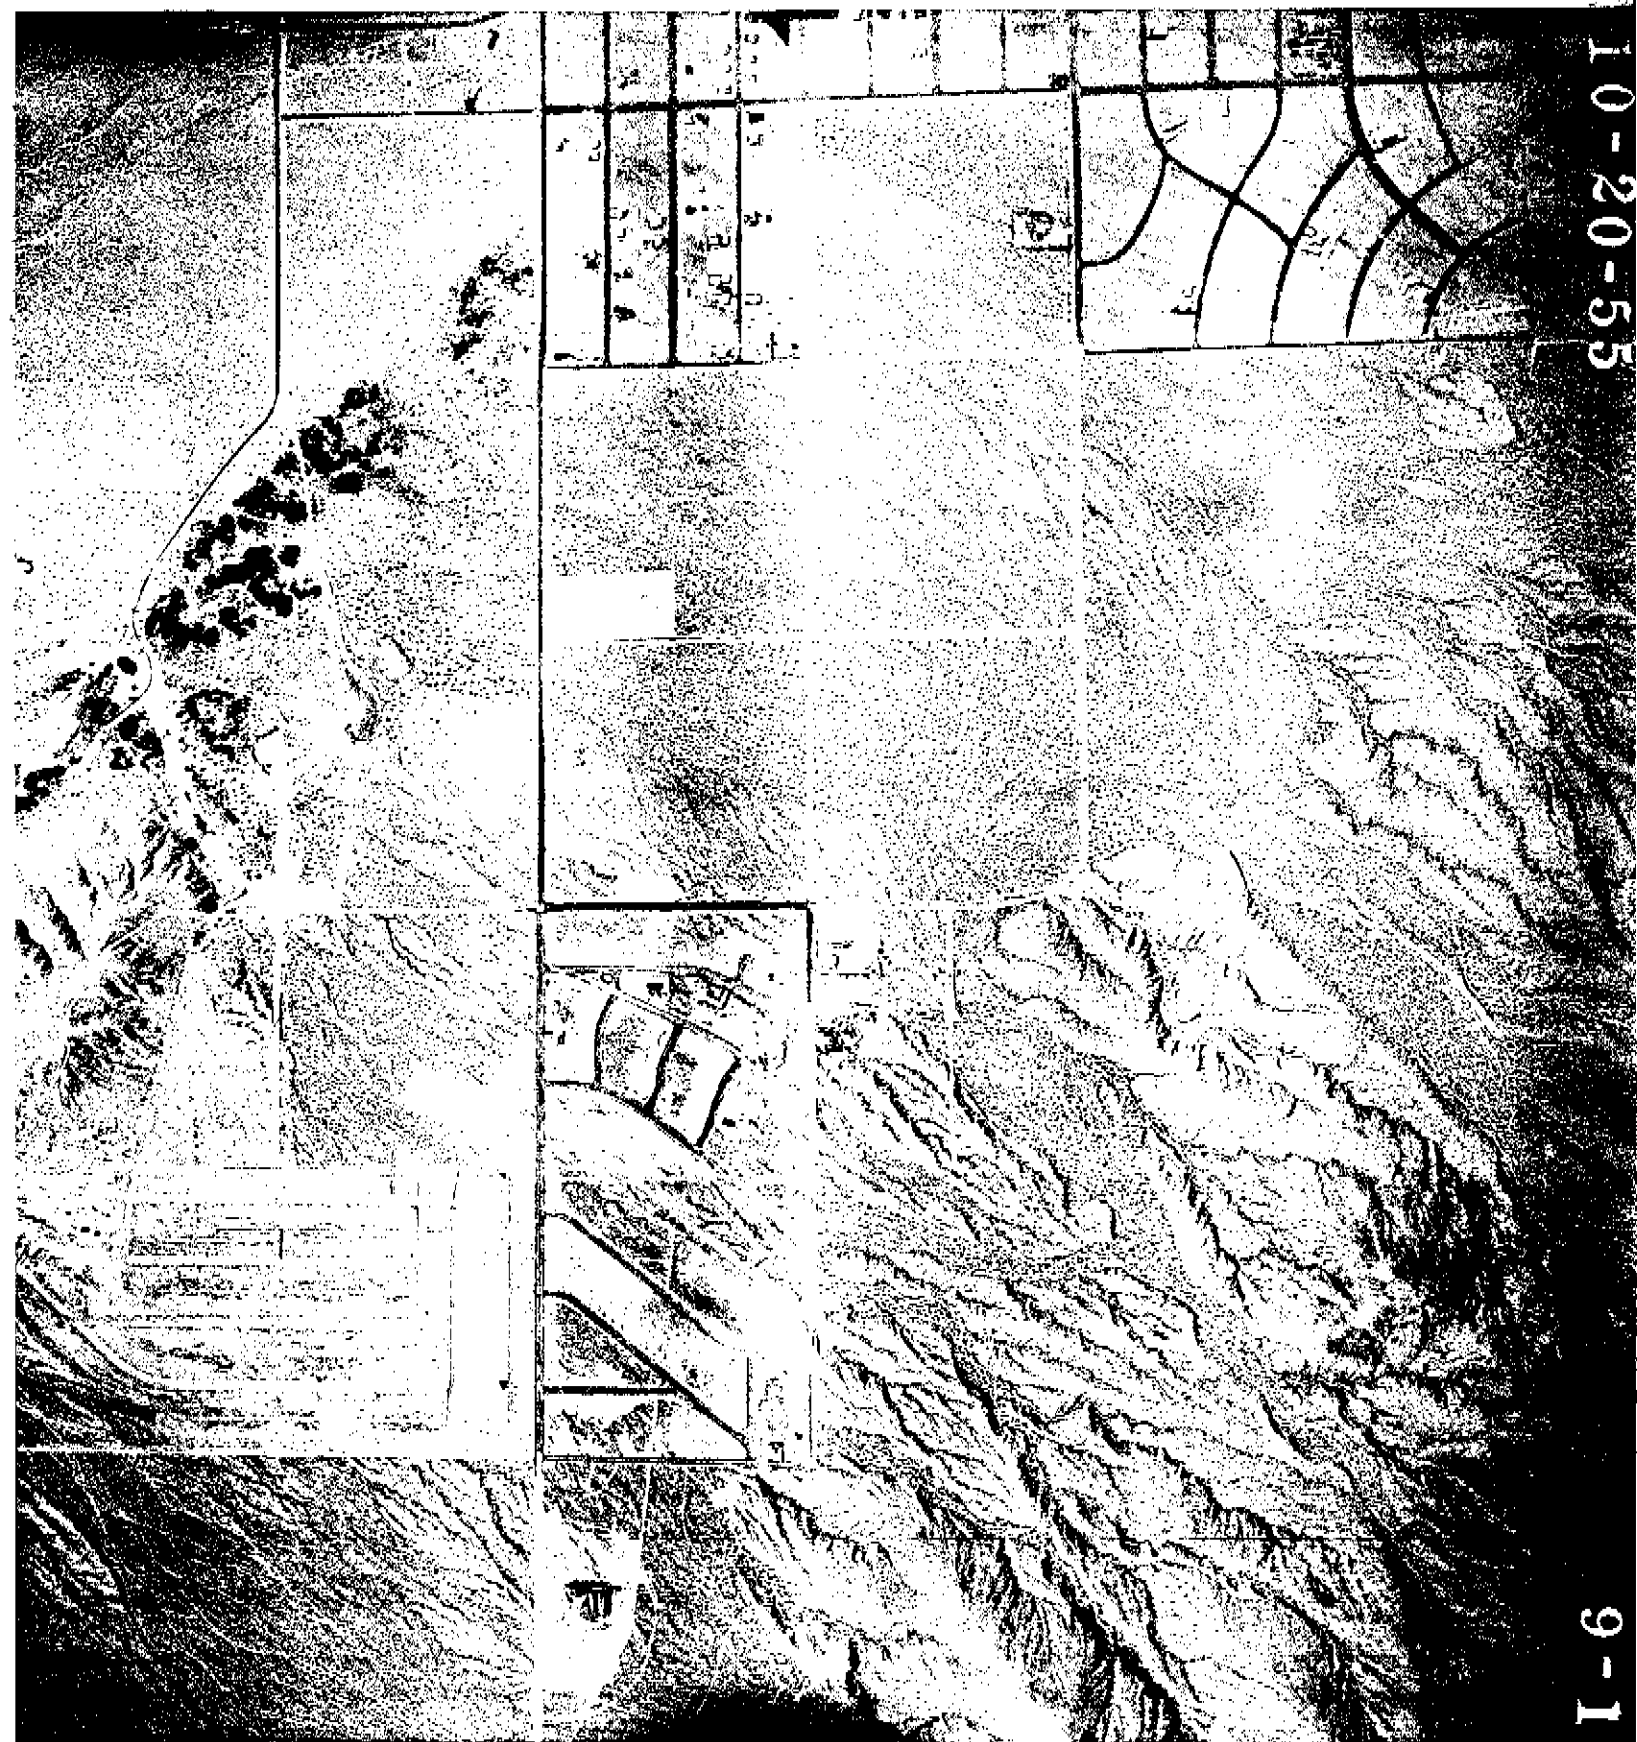
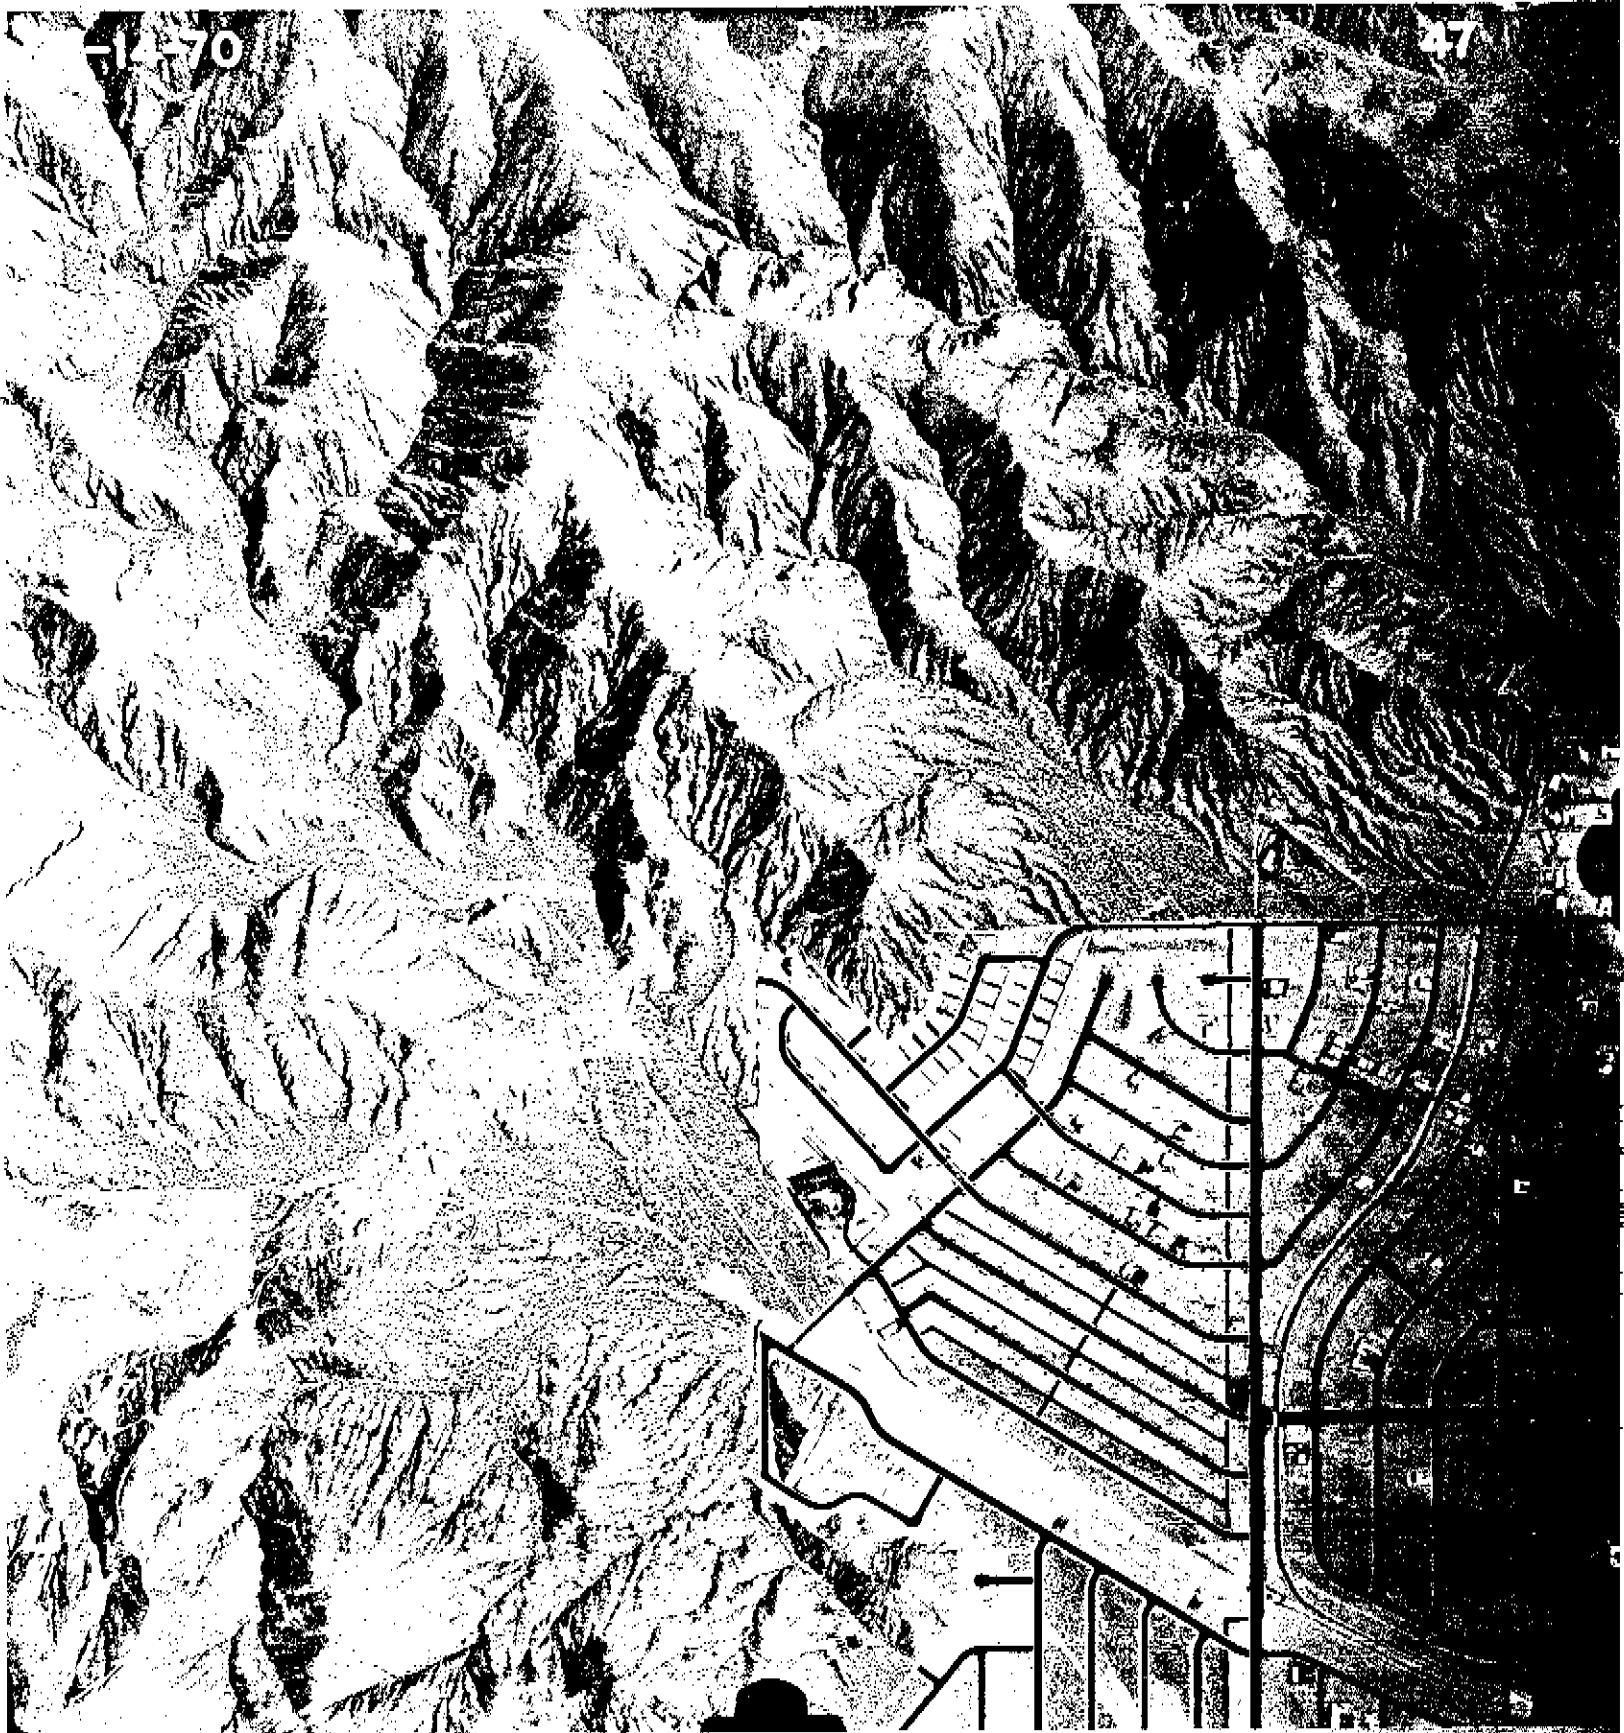
activities of man. The northeast-facing scarp mentioned by Rasmussen (p. 7) is clearly visible. However, the scarp is highly eroded, and dissection extends deeply into both the upthrown and downthrown sides of the fault. Furthermore, the area that Rasmussen investigated is nearly identical in geomorphic appearance to the area that I examined on the ground about one kilometer to the south along the fault. Because of this similarity, I tend to draw the same conclusion about recency of fault movement; none has occurred during Holocene time. Rasmussen believes that the faulted sediments on the southwestern side of the fault are of Holocene age. But he mentions, and shows on his logs (trench 1 and pit 1), that there are abundant caliche-filled cracks in that unit. It is my belief, based on the observation of many sedimentary units in this region, that significant accumulations of caliche occur only within alluvial units that are much older than Holocene.

1955, 1957, 1966, 1970 Air photos of Blind Canyon fault -- all borrowed from
Rasmussen (Riverside Flood Control), except 1966 WRD fr. LA district.
